**Wetland and Wildlife Habitat Monitoring Report  
Manchester Essex Conservation Trust  
Upper Pine Street  
ACOP-NE-09-6W018**

**December 7, 2011**

**REC**  
**Rimmer Environmental Consulting, LLC**

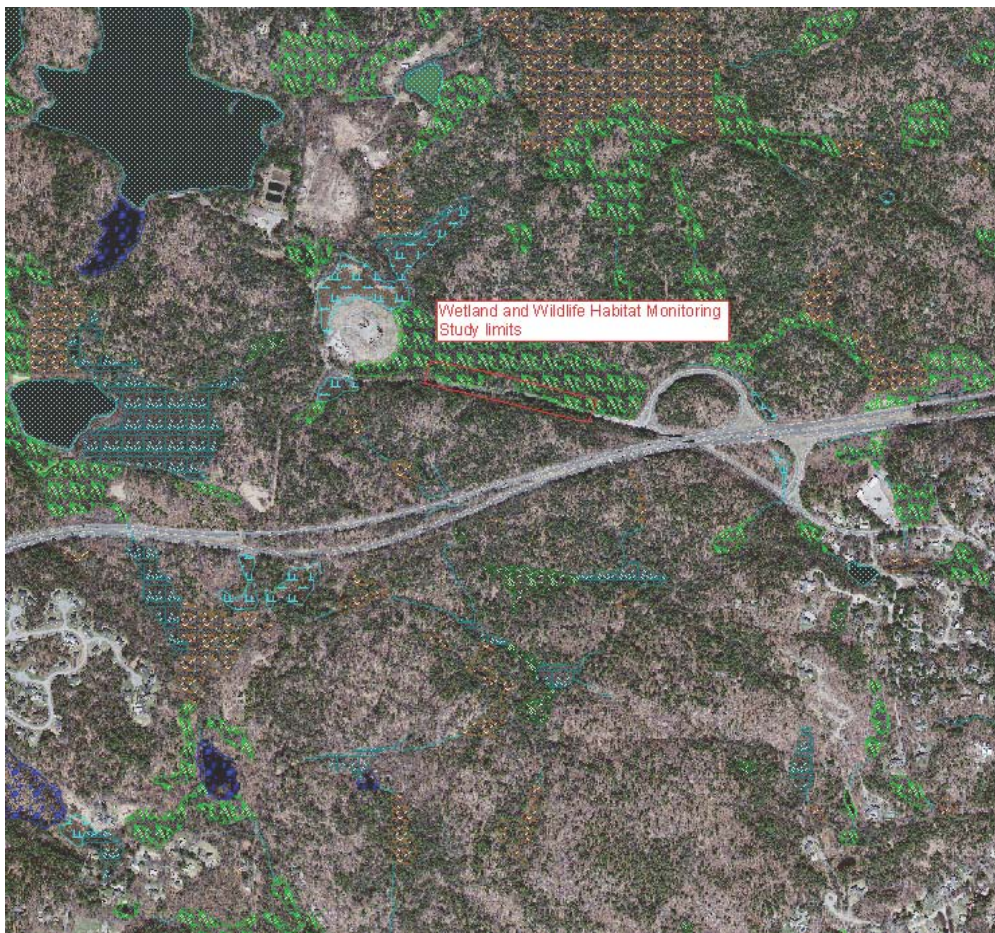
**Figure 1: Study Limits**

The study area extends approximately 1,100 feet west of the commencement of new paving and extends into wetland areas to the north and south a maximum of 120 feet from the edge of pavement as shown in Figure 1 below.

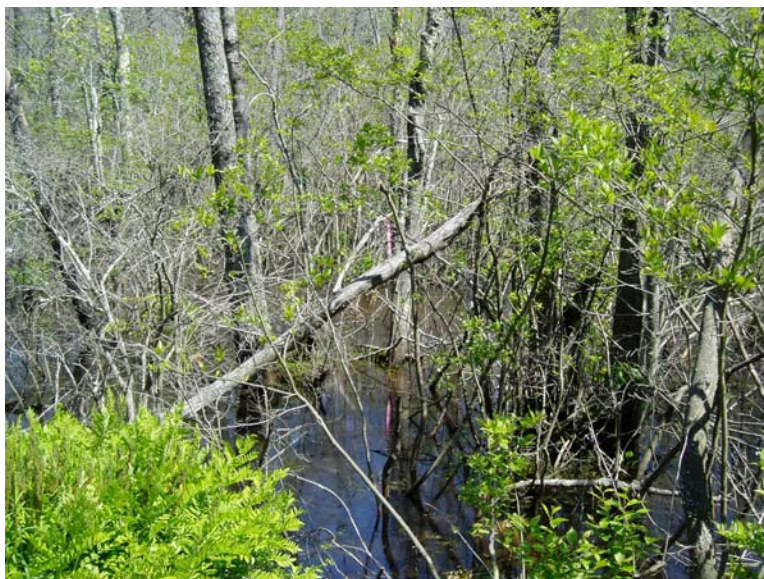
**1. Typical habitat**

The north side of the study area consists of an extensive forested wetland system known as Maple Swamp (see Figure 2). Using the classification system established in “Classification of Wetlands and Deepwater Habitats of the United States” (Cowardin, et al 1985), the site is a Palustrine scrub-shrub, seasonally flooded wetland. The area contains a moderate to sparse overstory of red maple (*Acer rubrum*) with a moderate to dense understory of shrubs, winterberry (*Ilex verticillata*) and northern arrow-wood (*Viburnum recognitum*) with sweet pepperbush (*Clethra alnifolia*), speckled alder (*Alnus rugosa*) and poison ivy (*Toxicodendron radicans*) near the road shoulder. Other vegetation includes royal fern (*Osmunda regalis*), bulrush (*Scirpus sp.*) and blueflag iris (*Iris versicolor*). Common reed (*Phragmites australis*) is found on the road shoulder and edge of wetland in the northwestern part of the project area.

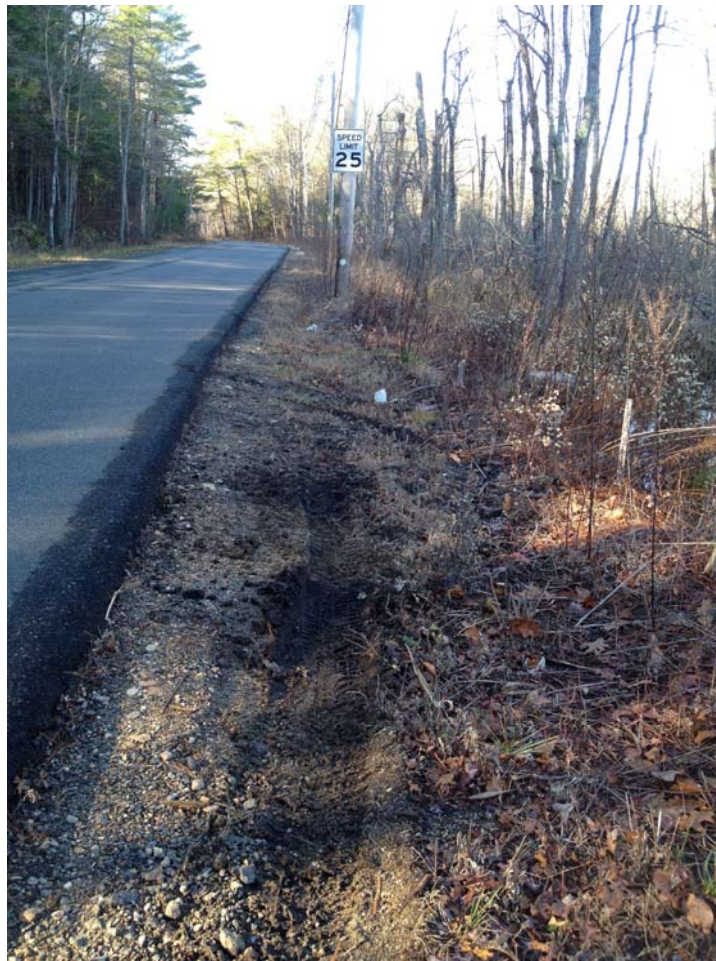
General wetland conditions in the main wetland on the north side of the road appeared very good, with a healthy diversity of plant species. The erosion control sock and stakes remains in place but is now significantly decayed and provides little function. Continued sedimentation of the wetland due to erosion from the roadway shoulder is likely without improved vegetative cover.

There did not appear to be any functional deficits of this wetland system as a result of activities conducted by MECT. Poor water quality at the two outlets indicates that sediment is still likely entering the system. Some erosion and bare spots on the roadway shoulder was also observed.

Road shoulder on north side of Pine Street in study area. Erosion control sock and stakes remain in place but have deteriorated
